## Feed Flow Line Troubleshooting

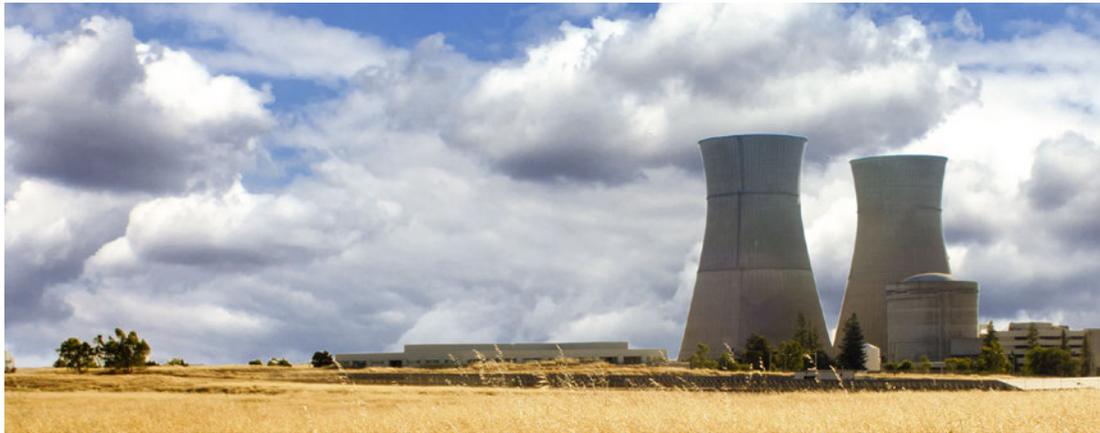
A power plant was experiencing a feed water flow problem. The issue was on a line with static pressure exceeding 1000 psi which fed water to one of their steam generators. The plant's engineers suspected that it may be an issue with a filter, a flow nozzle, or even with the line itself, but couldn't know for certain until they could isolate and

capture one of the transient events. Logging differential pressure—so that they could record readings on both sides of the suspected problem areas—would be the best way to troubleshoot the issue. But that method was initially dismissed by the team, as the cost for a unit to measure differential pressure under so much static pressure would be very expensive.

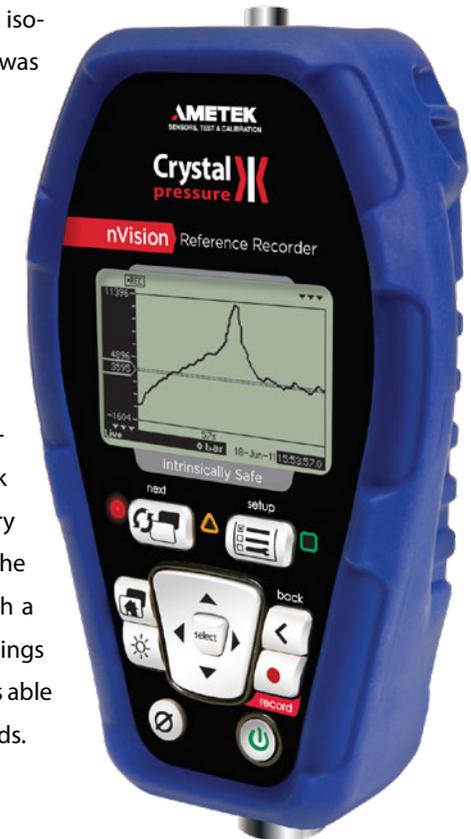
Crystal Engineering had the solution. Equipped with two pressure modules rated in excess of the static pressure, an nVision reference recorder could provide the plant's engineers an accurate differential measurement. The nVision would capture the native difference between two modules of the same range (in this case 3000 psi) and apply

that difference to each measurement. This would give them a differential pressure measurement up to an accuracy of  $\pm 1.4$  inH<sub>2</sub>O; even with the high static pressure present in their system. And, as the nVision would record and time stamp the data, the engineering team would have the ability to carefully analyze the differential measurements and
